Experience of Shipboard Firefighting with Cutting Extinguishers

Anders Trewe, Cold Cut Systems Svenska AB

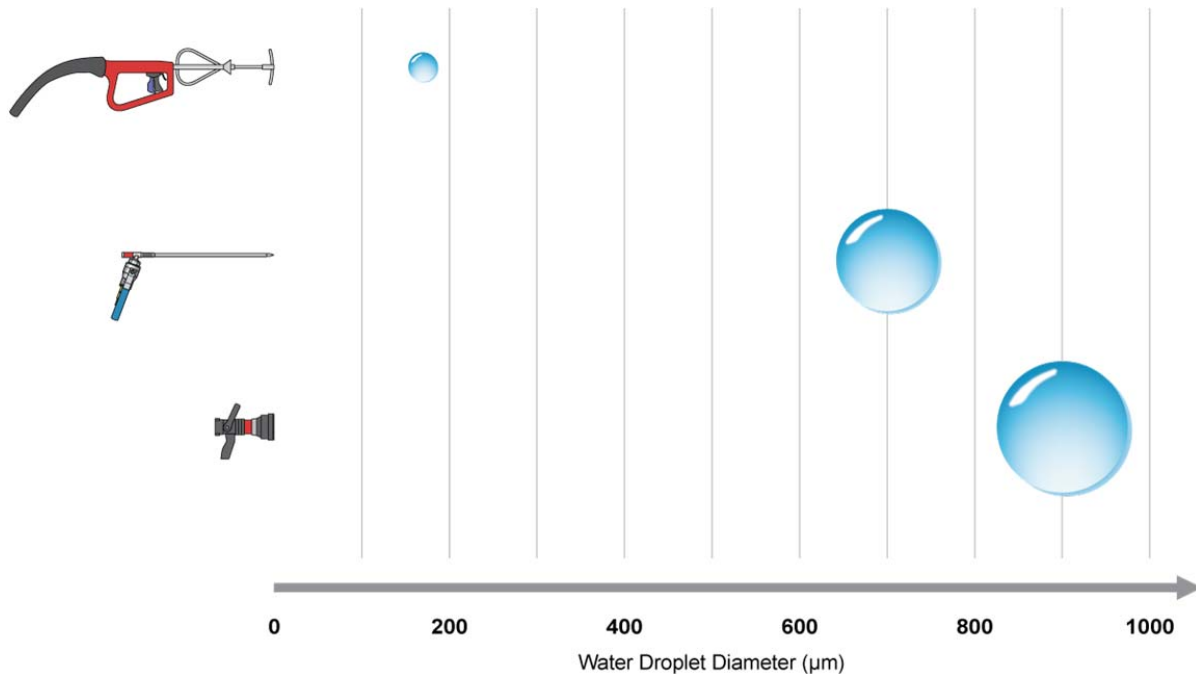
Figure 2 Water droplet Sauter mean diameter of different fire fighting tools, adapted from additional tests to (Svensson, Lindström, Ochoterena, & Försth, 2014)

When studying the efficiency of water mist in heat extraction, a measurement that relates the volume of the droplet to the surface of the droplet is necessary. This measurement is called Sauter Mean diameter. Studies made by SP Technical Research Institute of Sweden shows that the Cobra cutting extinguisher produces a water mist at a Sauter Mean diameter of 170 microns (60 micron arithmetic mean diameter) 10 meters from the nozzle. By introducing an additive to the water, such as a Class A surfactant or a saline additive, the water droplets size decrease significantly, thus expands the surface area exposed; the Sauter Mean decreases to 110-150 microns.¹¹ This confirms initial tests by the Swedish Navy showing that if the cutting extinguisher was utilized with a Class A detergent, the gas cooling is even more apparent¹².

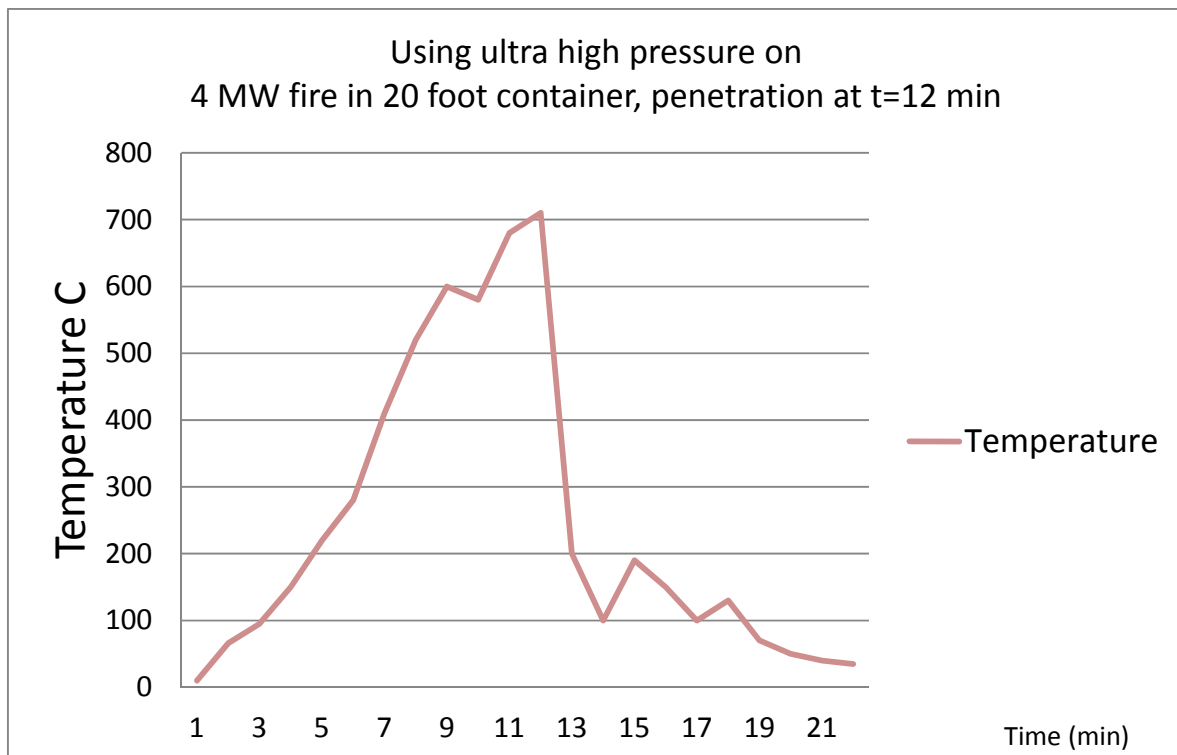
Figure 4 Rapid Temperature Reduction

A typical scenario is a fire room of 75 cubic meters (2.4m x 6.5m x 5.0m) with a 3.6 MW fire (diesel pool of 3.6 square meters). With a fully developed fire, the temperature of the room is approximately 600 C. By applying a 28 liter per minute cutting extinguisher, the temperature will decrease to 100 C in 30 seconds, using just short of 15 liters of water.¹⁷

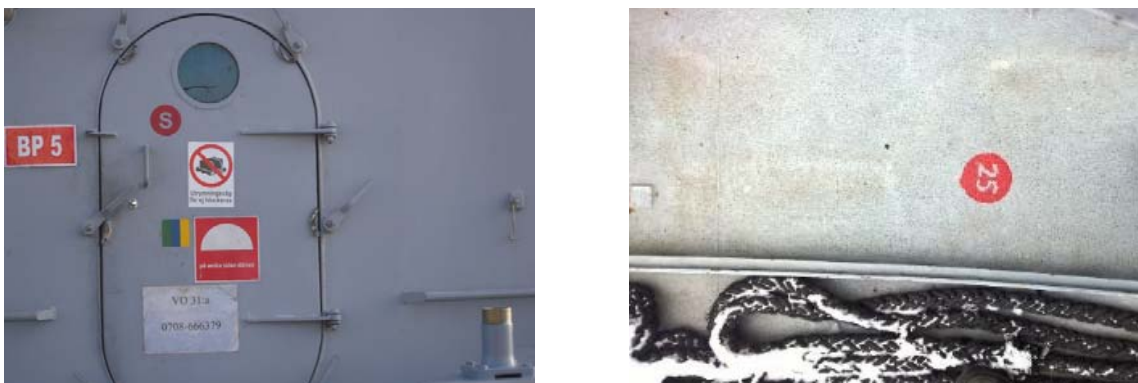
Figure 5 Cutting extinguisher Attack Point “(S)” at a hatch and “(25)” on deck, photos courtesy Royal Swedish Navy

The CAPs are mapped on DC drawings, numbered from stern to aft, even numbers on port side and shows fire sections of the ship. DCO uses the numbers to give command for cobra attack. On deck and hatches, the CAPs are marked with bright red markings. The markings are placed according to a set of criterions; plausible fire starters, avoiding critical installations, ship construction, accessing and maintaining the CAPs.

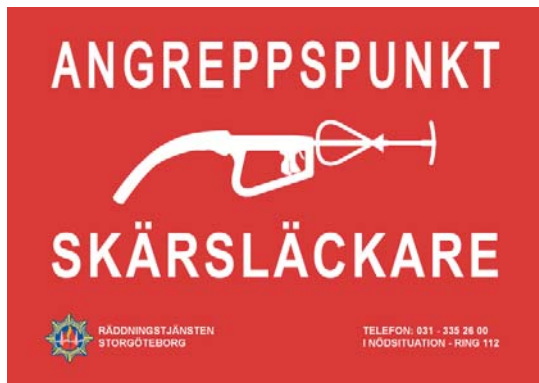
Figure 7 CAP adopted by Greater Gothenburg Fire and Rescue Service, illustration courtesy GGFRS

The use of pre-determined CAPs has been adopted by civilian fire and rescue services, for instance Greater Gothenburg FRS at industrial and heritage constructions.

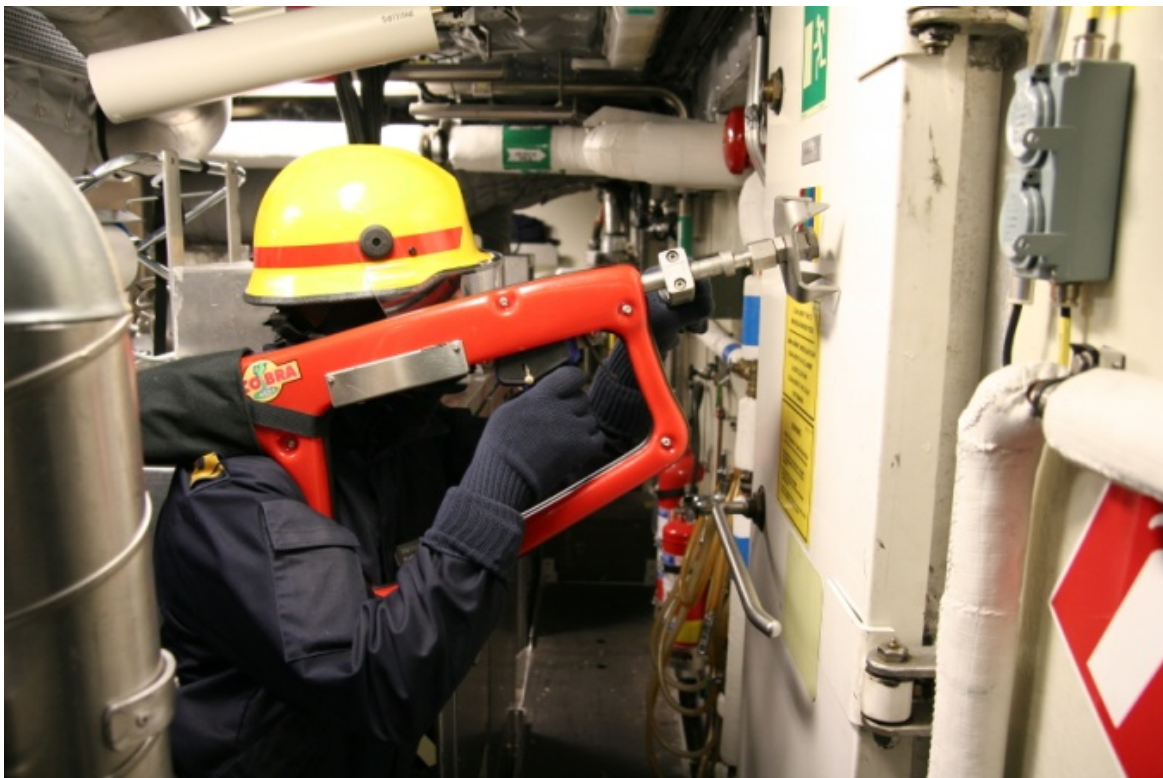
Figure 10 Cobra Attack – Second Attack onboard Visby Corvette

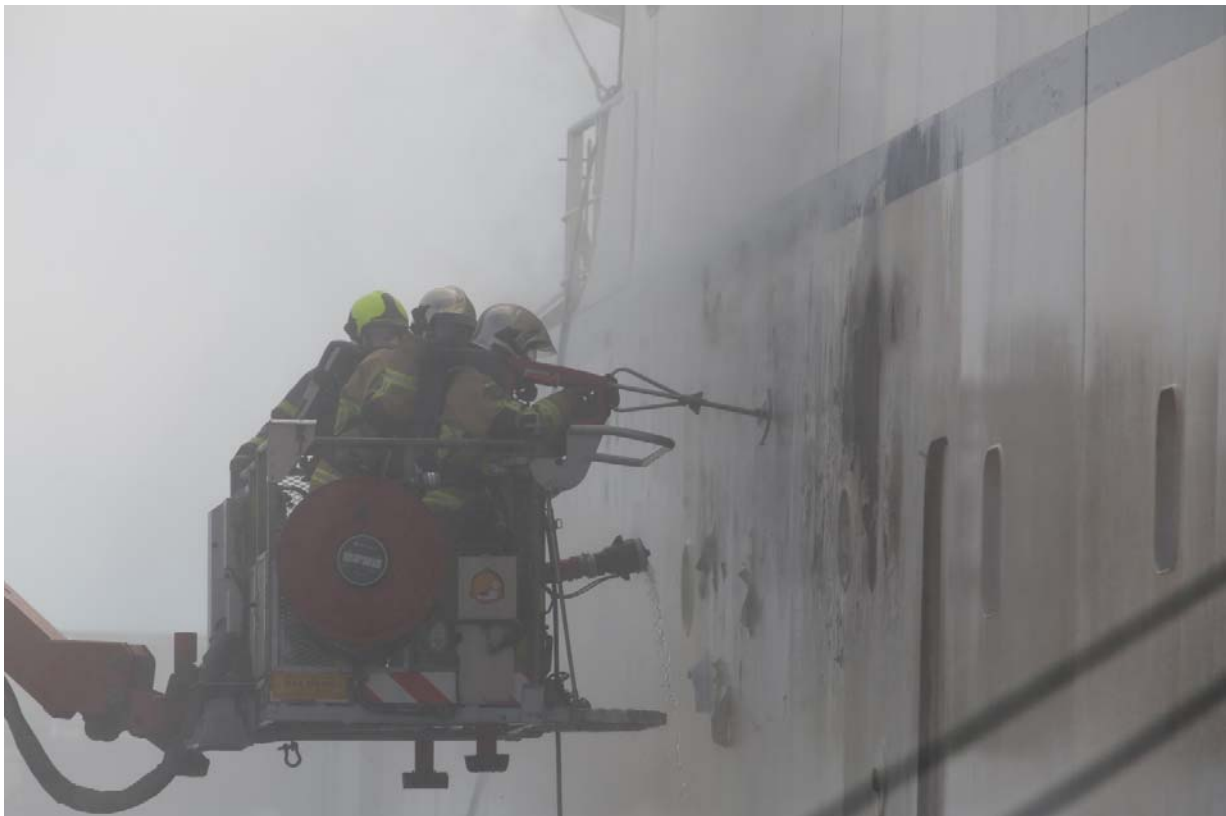
Figure 13 Cobra Cutting Extinguisher applied by Amsterdam Amstelland Brandweer from an aerial ladder on the SCH 118

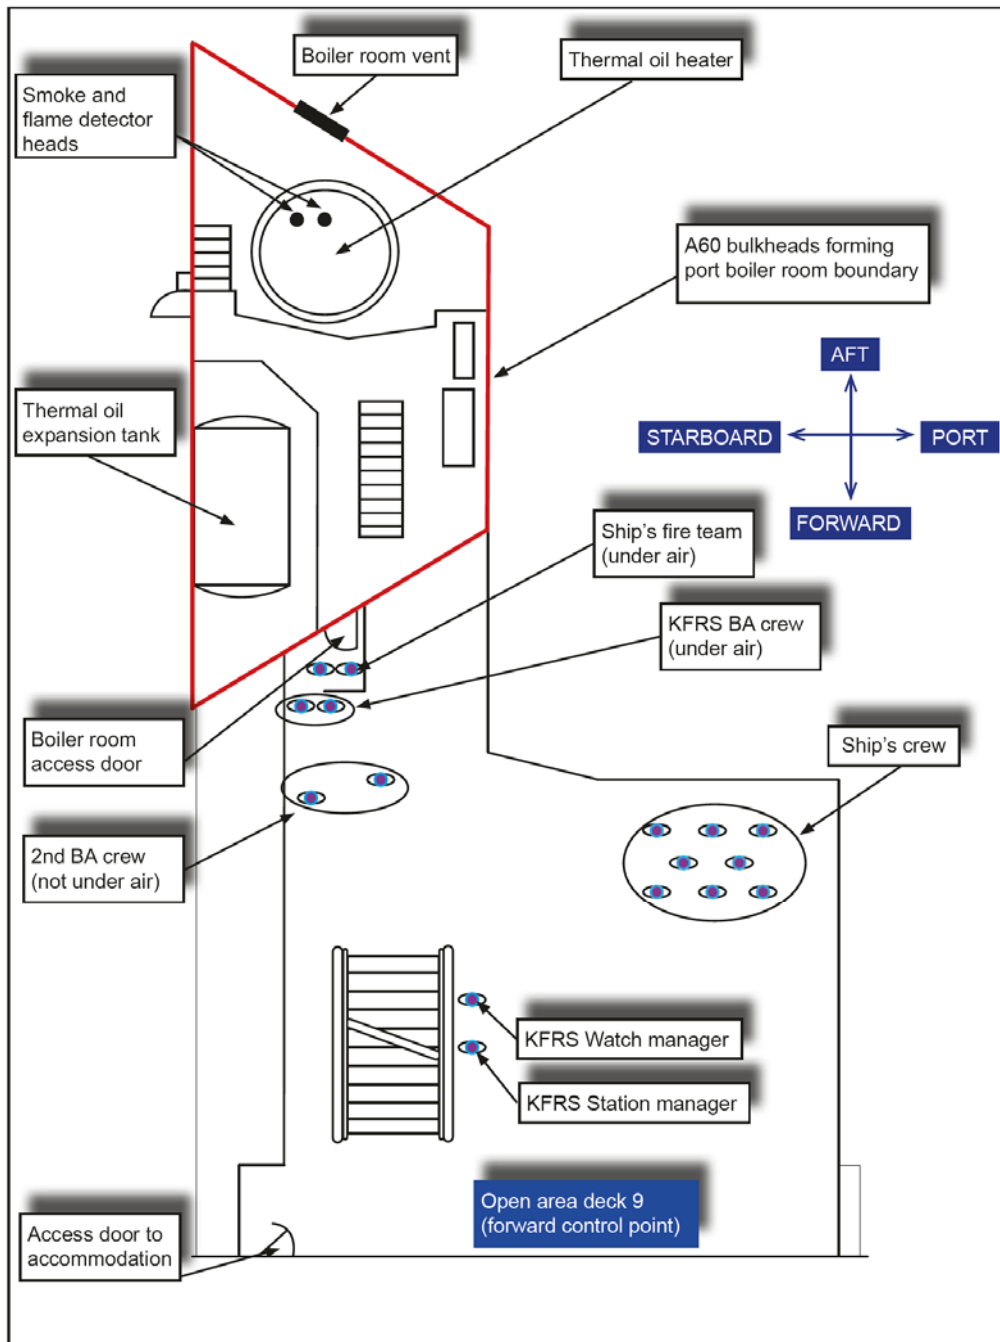
Figure 14 Diagram of location of port boiler room and personnel at the time of fire ball. Illustration with courtesy to MAIB

A forward control point was set up by the Kent FRS adjacent to the entrance of the port boiler room at deck 9. Monitoring the exhaust gas temperature from the furnace, it became apparent that the temperature had risen from 280 C to 340 C between 13.25 and 13.41. Not known at the moment, there

was a leak of oil into the furnace. It later showed that the hatch of the furnace was not shut properly and that heat from the uncontrolled fire was emerging through the open hatch into the boiler room at deck 9.
